# Thinking of the Future

When it comes to quality and hygiene St Monica Trust found what they were looking for from Electrolux Laundry Systems

### Time For a New Laundry Solution

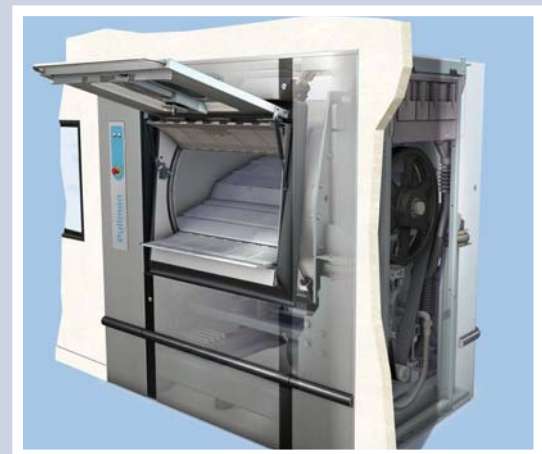
*A barrier washer extractor*

With a barrier laundry, clean and dirty linen never come into contact with each other meaning cross contamination is avoided. A Barrier washer extractor has two doors located on opposite sides of the machine. This allows the machine to be installed in a wall that divides two separate laundry rooms. Dirty linen is loaded into the machine in one room (the dirty side) and the clean linen is then unloaded into the other room (the clean side).

Both doors can never be opened at the same time and staff moving from the dirty side to the clean side must pass through a tiny room where contaminated gloves and gowns are removed and hands are thoroughly washed. On a regular basis and at several stages of the laundering process, laundry staff measure the microbiological quality of the linen which should be lower than 12 colonies per 25 cm<sup>2</sup>.

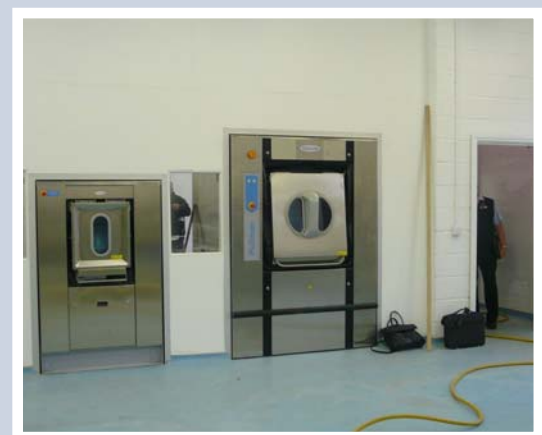
*The body of the machines sit in the dirty side. On the clean side they are flush to the barrier wall (as above).*

*To the right is the door to the airlock where staff must wash their hands and remove protective gowns.*

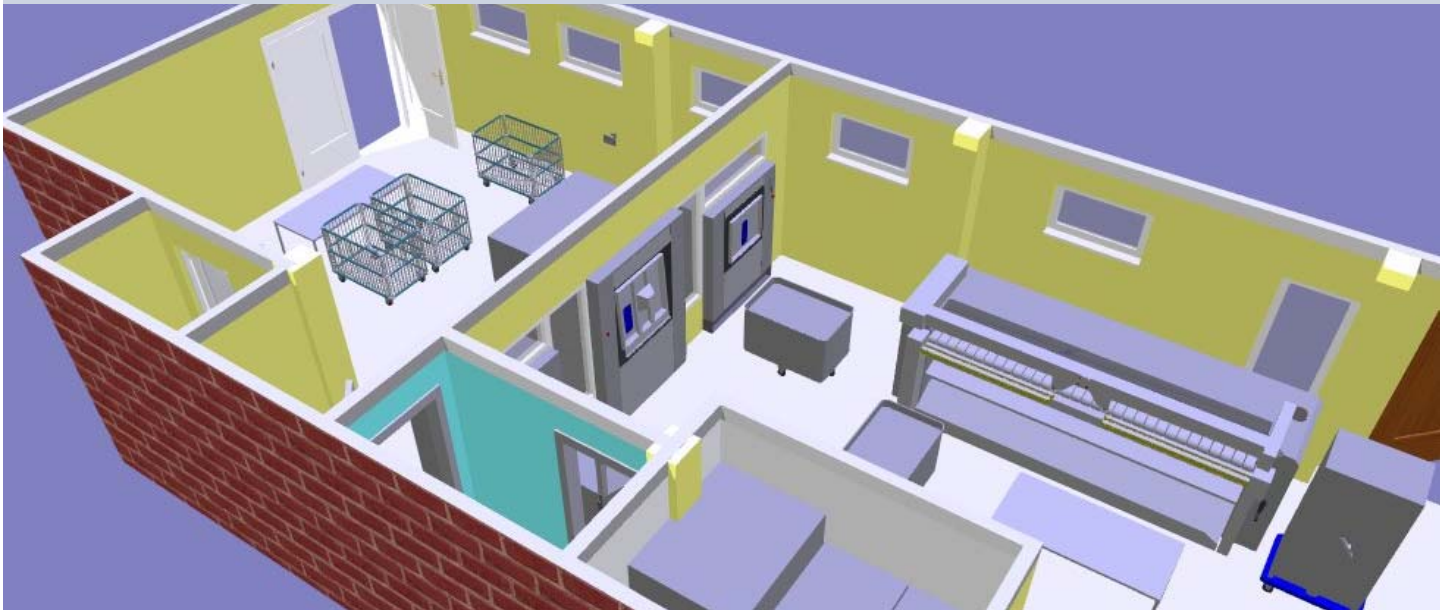
*One of the first plans drawn up by Electrolux Laundry Systems*

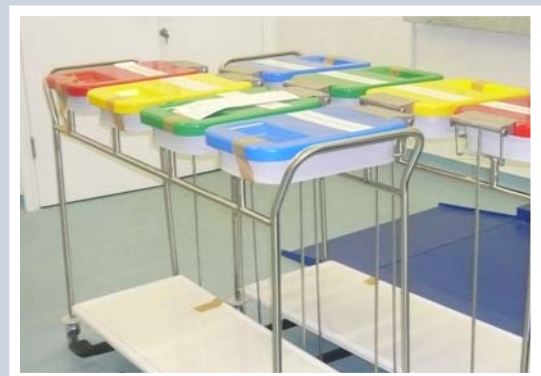
*A barrier laundry is not just about the machinery. Just as important is the hygienic process used. For this reason, it was important to consider the way in which the staff would work and any new equipment they would need such as trolleys, coloured bags for different laundry, PPE etc.*

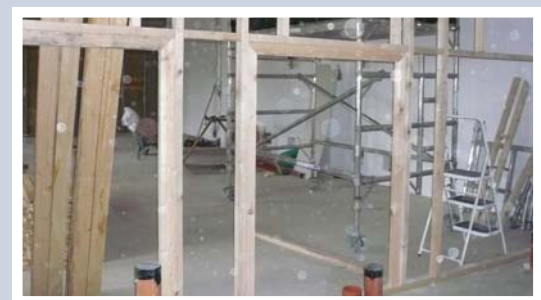
*Putting in the barrier wall*

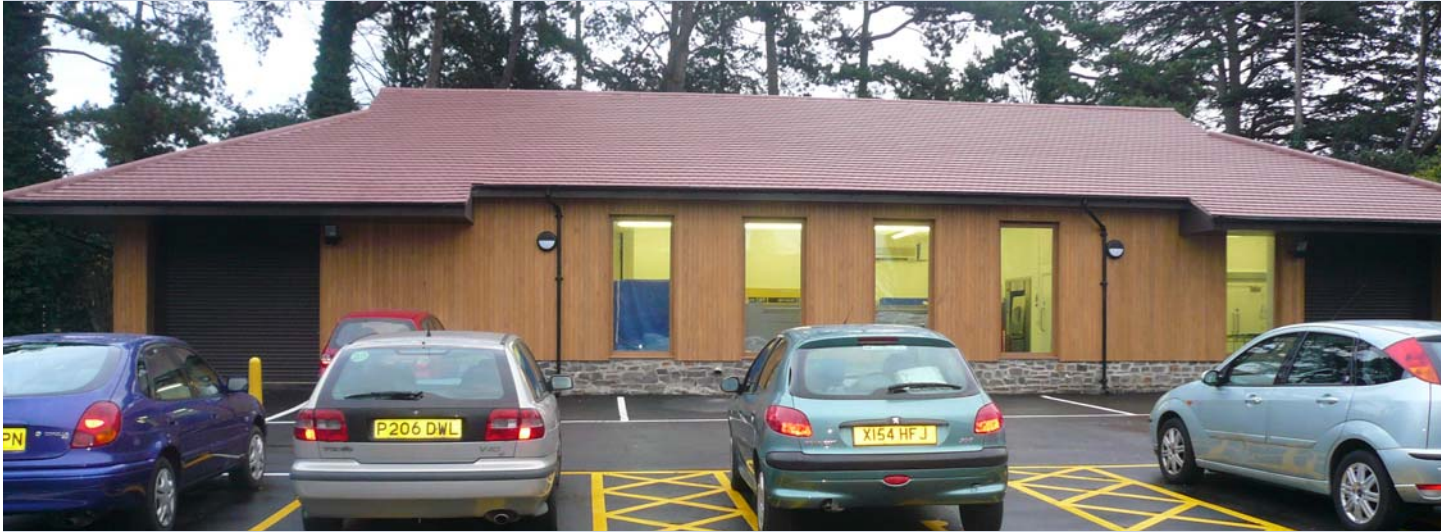
*The finished laundry.  
Right hand door = laundry delivered to the dirty side. Left hand door = clean laundry collection.*

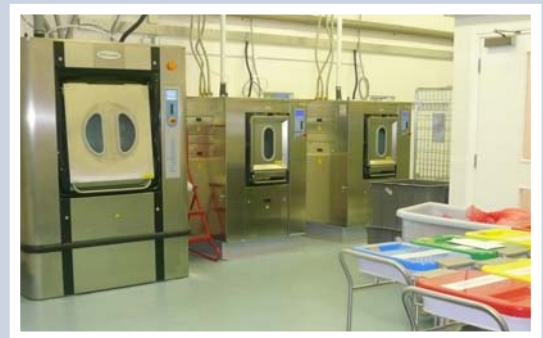
*The dirty side with the three barrier washers.  
Towards the right is the door to the refrigerated room for weekend storage.*

As dirty laundry was to be stored over the weekend, a refrigerated room was built into the laundry plans to prevent any bacteria growth.

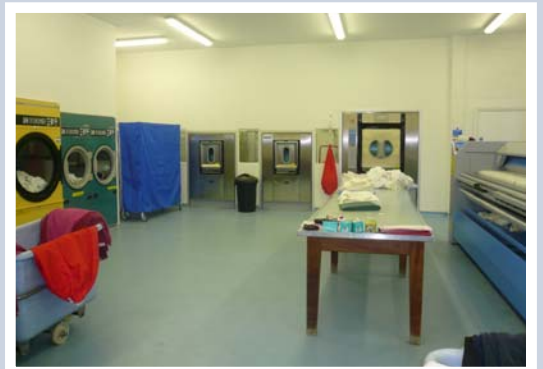
*The clean side. Laundry to be tumble dried goes along one side of the room and flatwork to be ironed flows along the other side.*
